**VANESSA ANDREW M.A.**

**FINE ART CONSERVATOR**

## **TREATMENT REPORT**

Owner:	Williamson Museum and art Gallery
Title:	Self portrait
Artist:	Philip Wilson Steer
Dimensions:	740mm x 593mm
Medium:	Oil
Support:	Canvas
Date of report:	March 2025

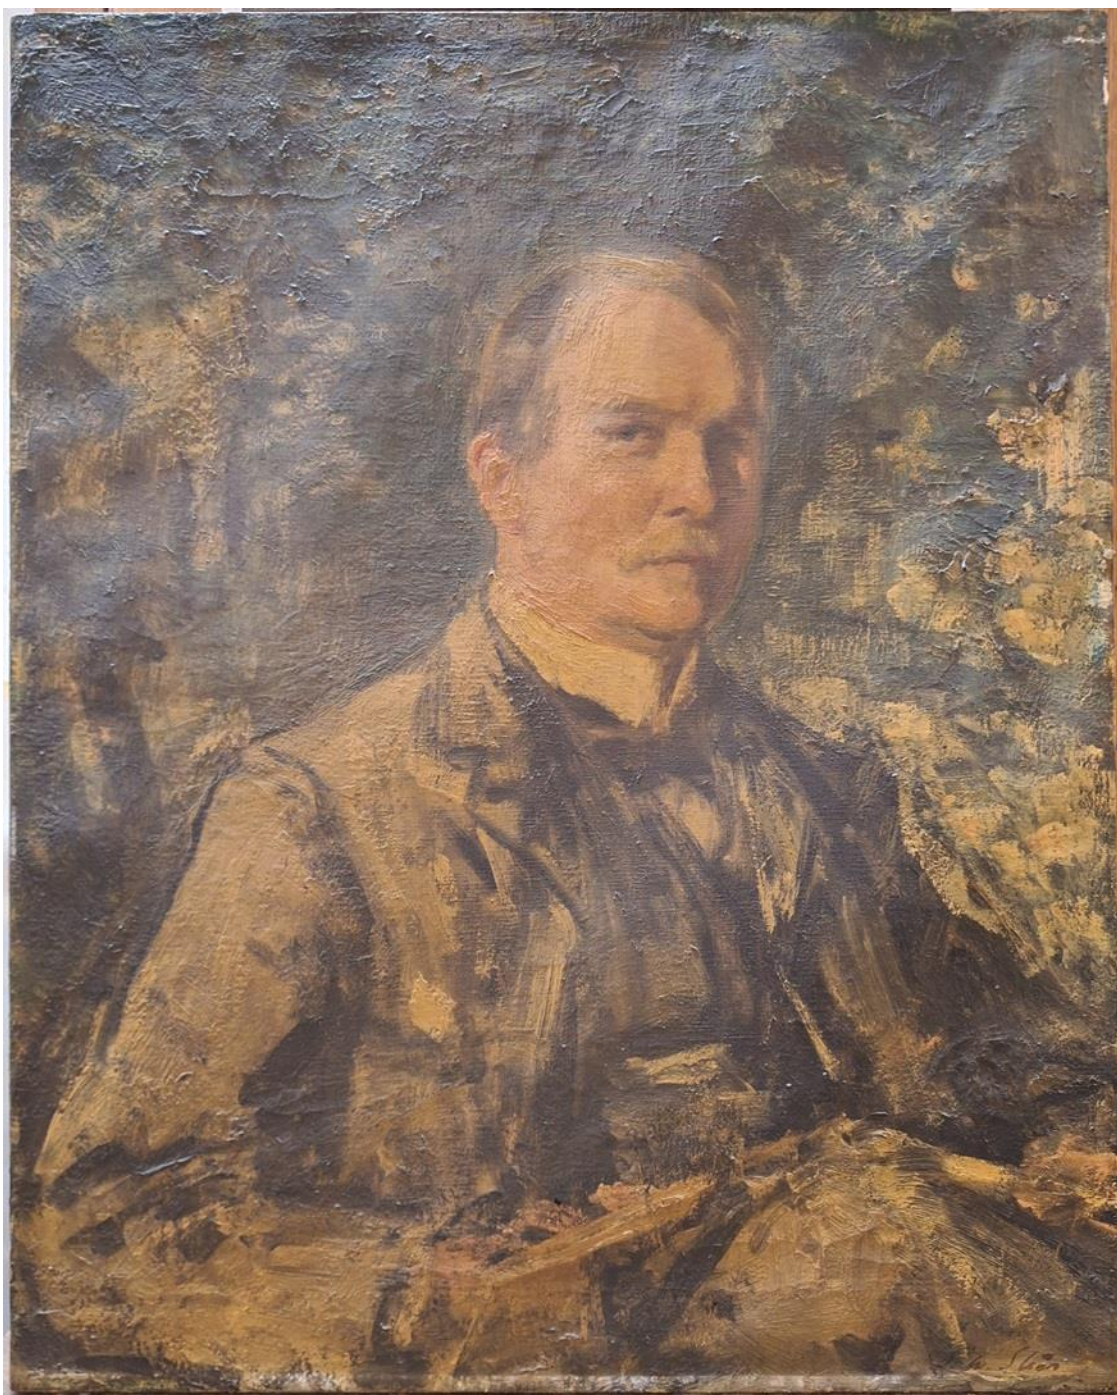
The draws in the canvas that could be seen towards the upper edge and extending down into the painting were resolved by replacing the missing tensioning keys.

Front of the painting before treatment showing the discoloured appearance and distortions in the canvas towards the upper edge.

The painting was then keyed out to give an even tension throughout and then the keys were tied in position.

The varnish layer had discoloured and yellowed considerably. The varnish layer was removed with Acetone applied through Stoddard's Solvent.

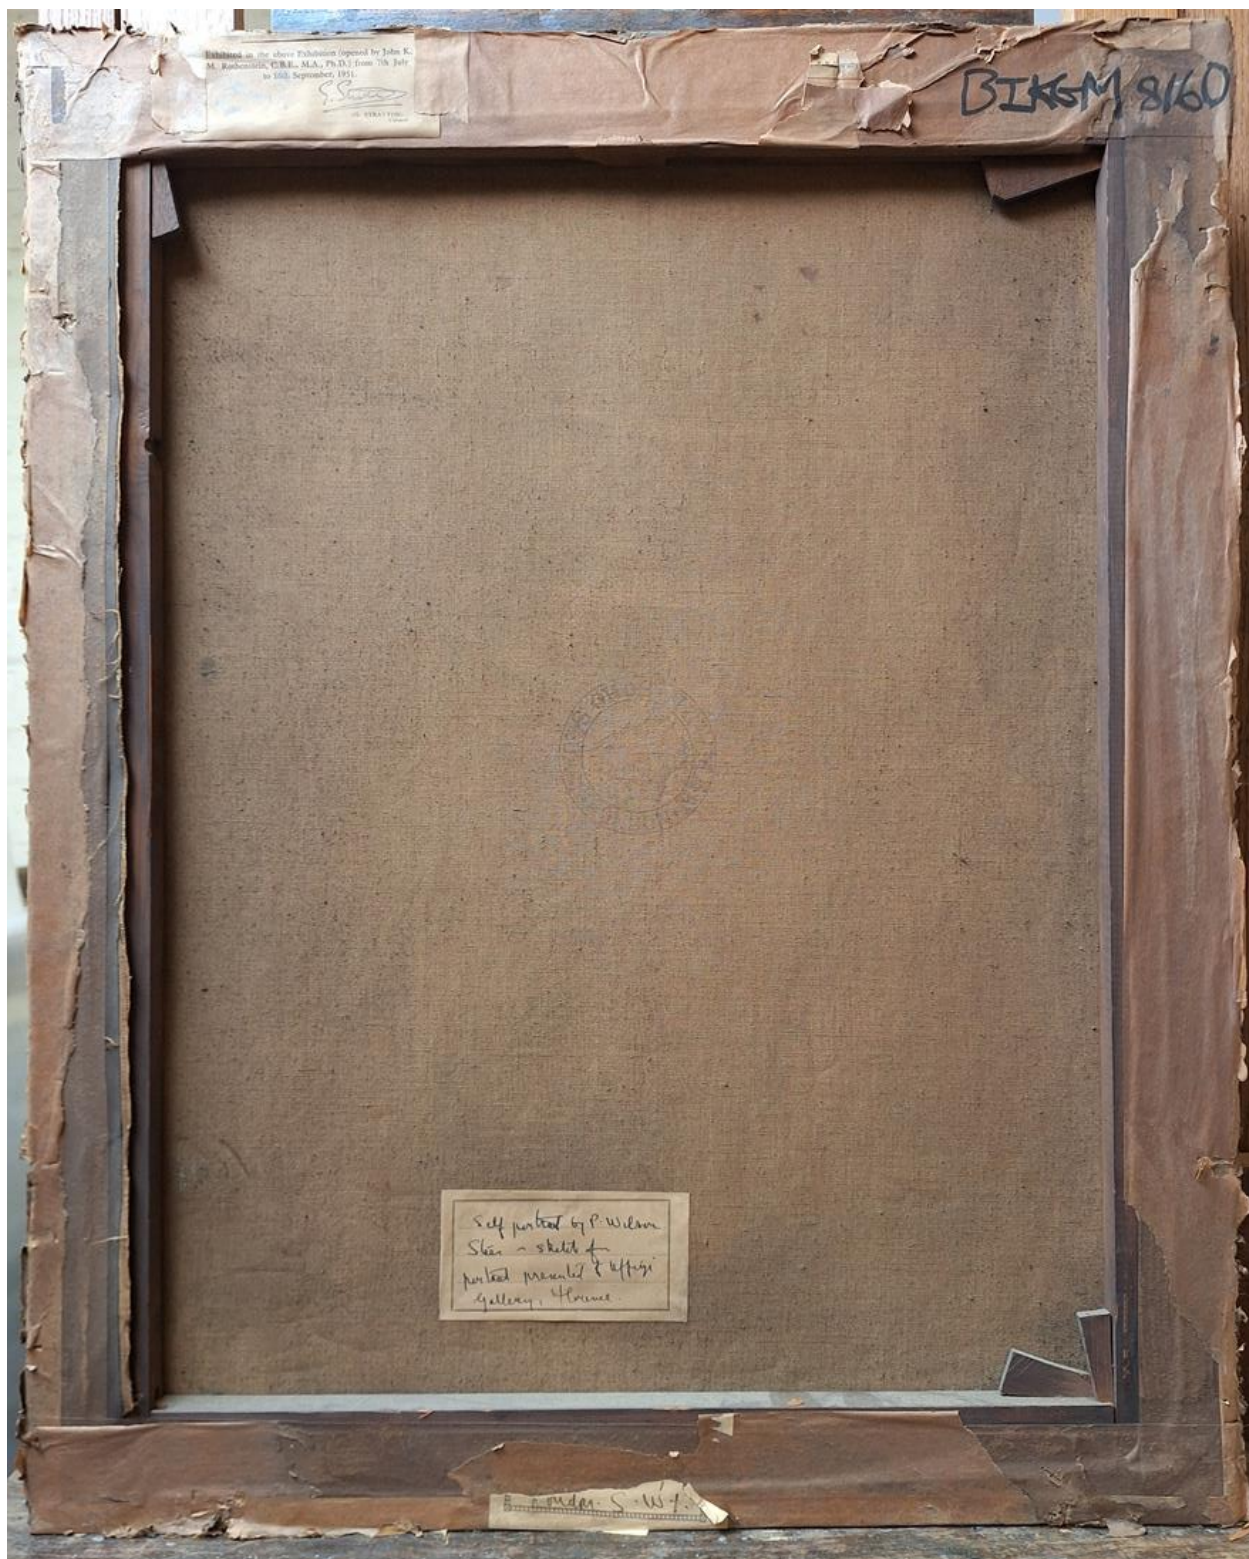
Reverse side of the painting before treatment showing the missing tensioning keys.

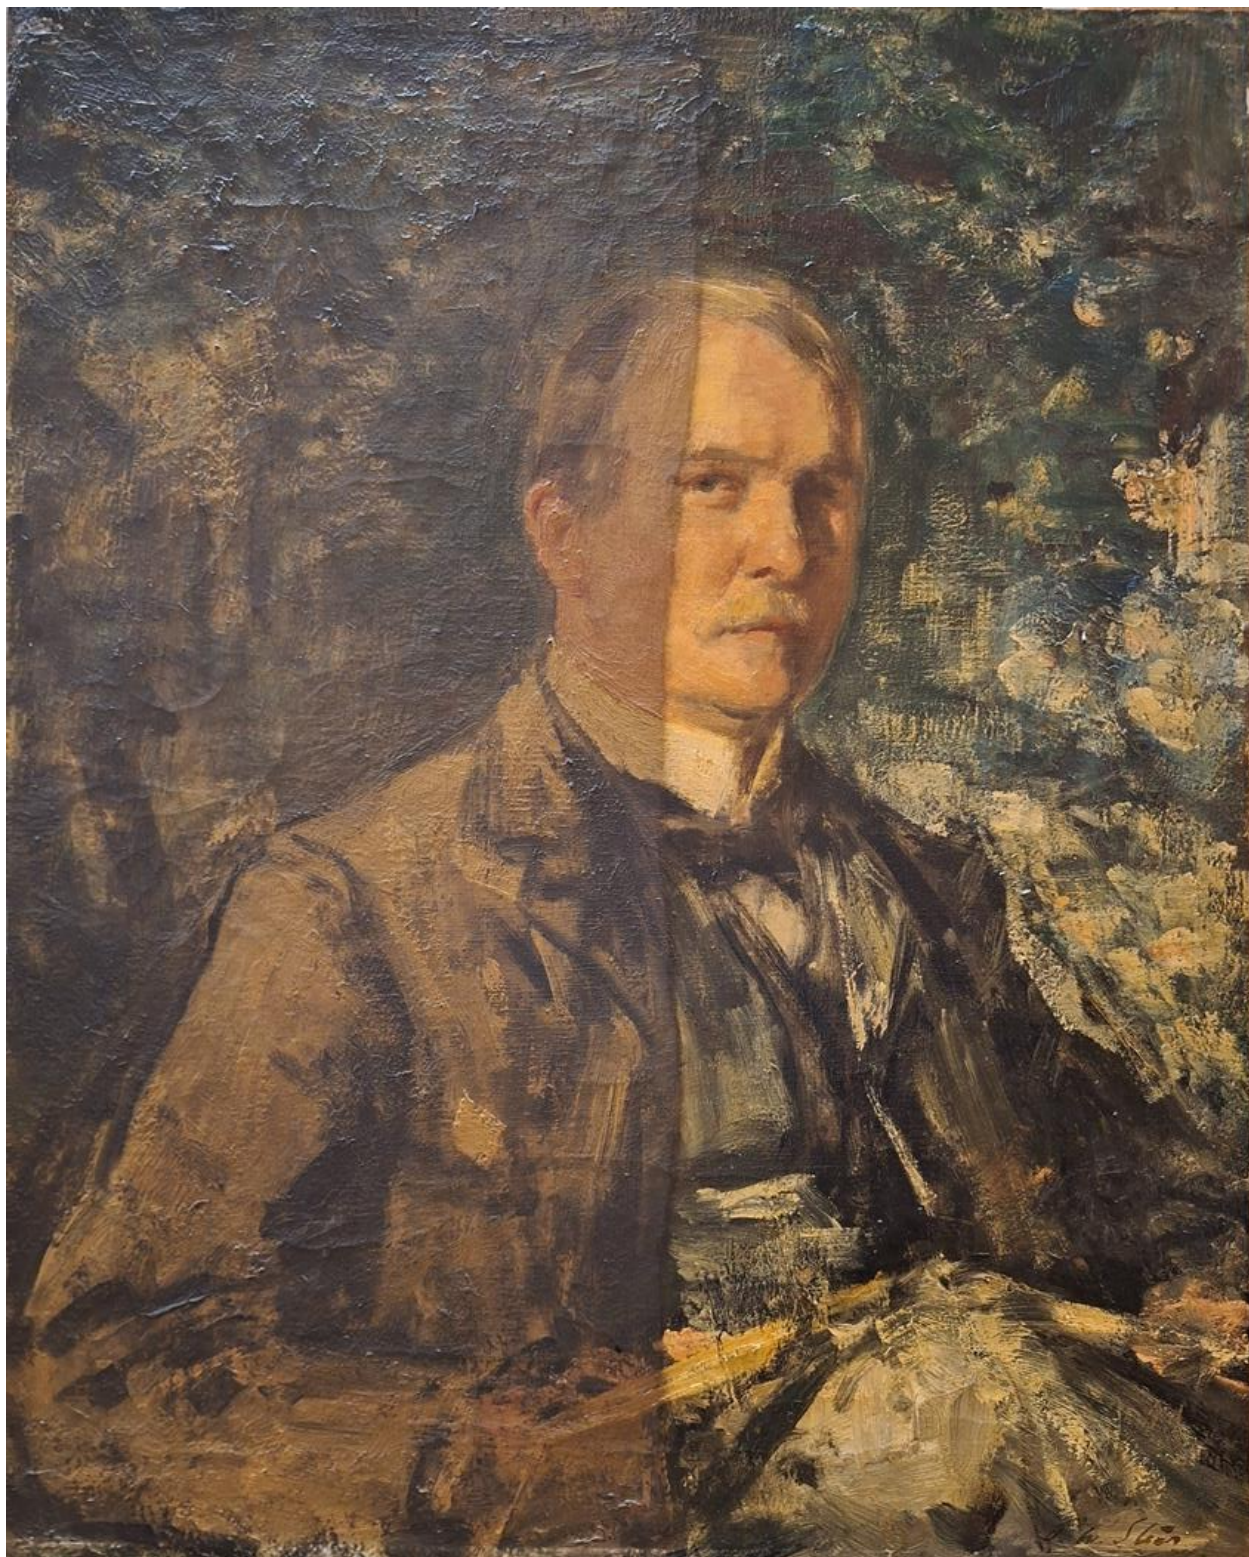
The painting had been in storage for many years and there was a considerable amount of surface dirt over the painting obscuring the image.

Front, during the removal of the surface dirt.

The surface dirt was removed with Tri-ammonium Citrate 3% in deionized water.

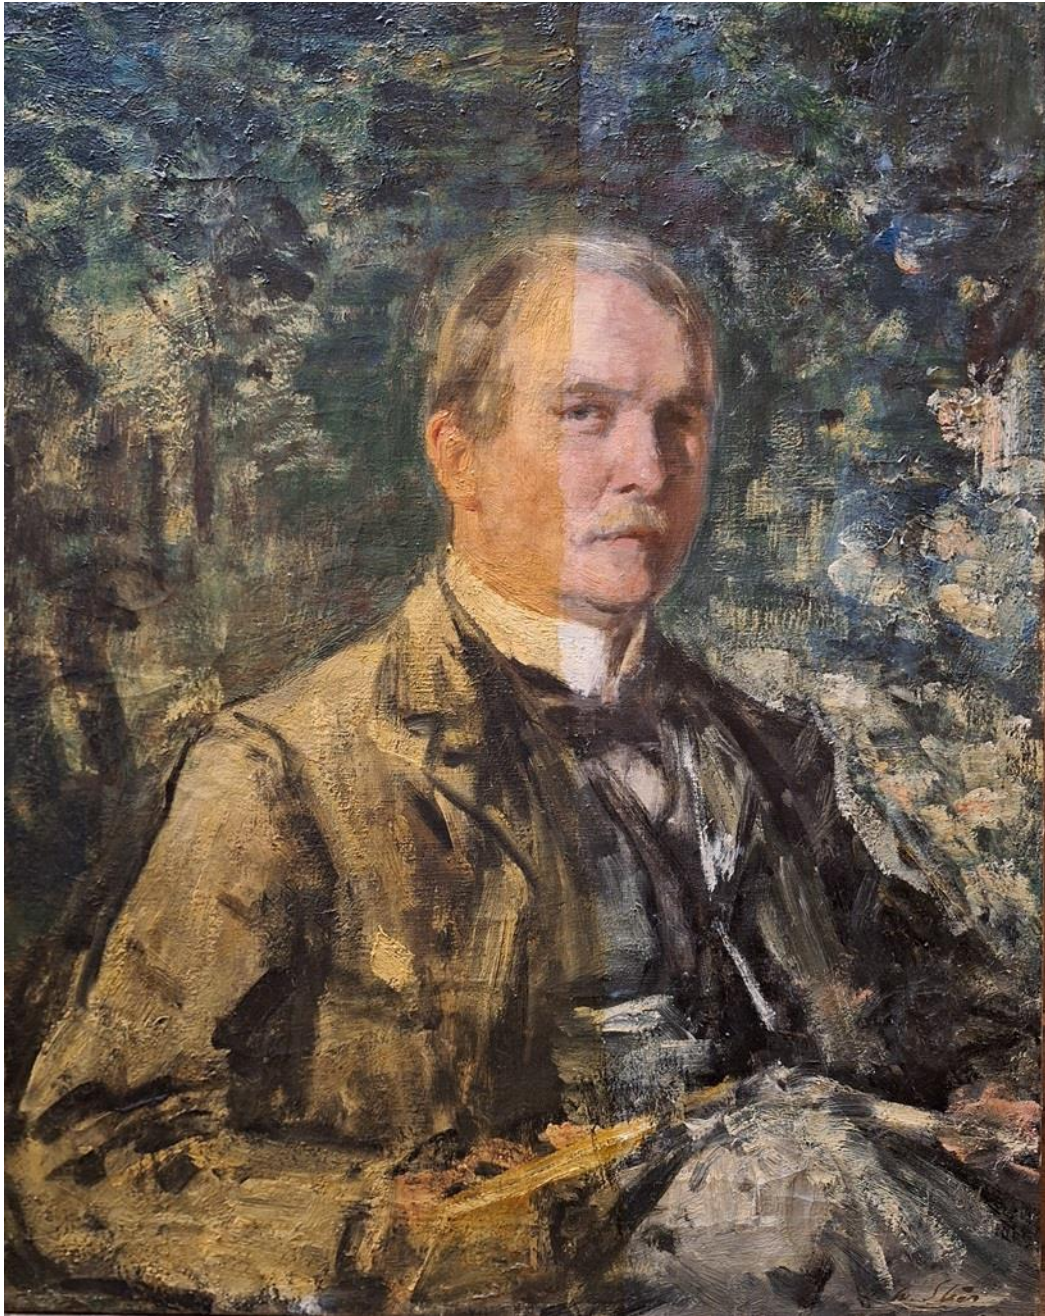
Front, during the removal of the varnish layer.

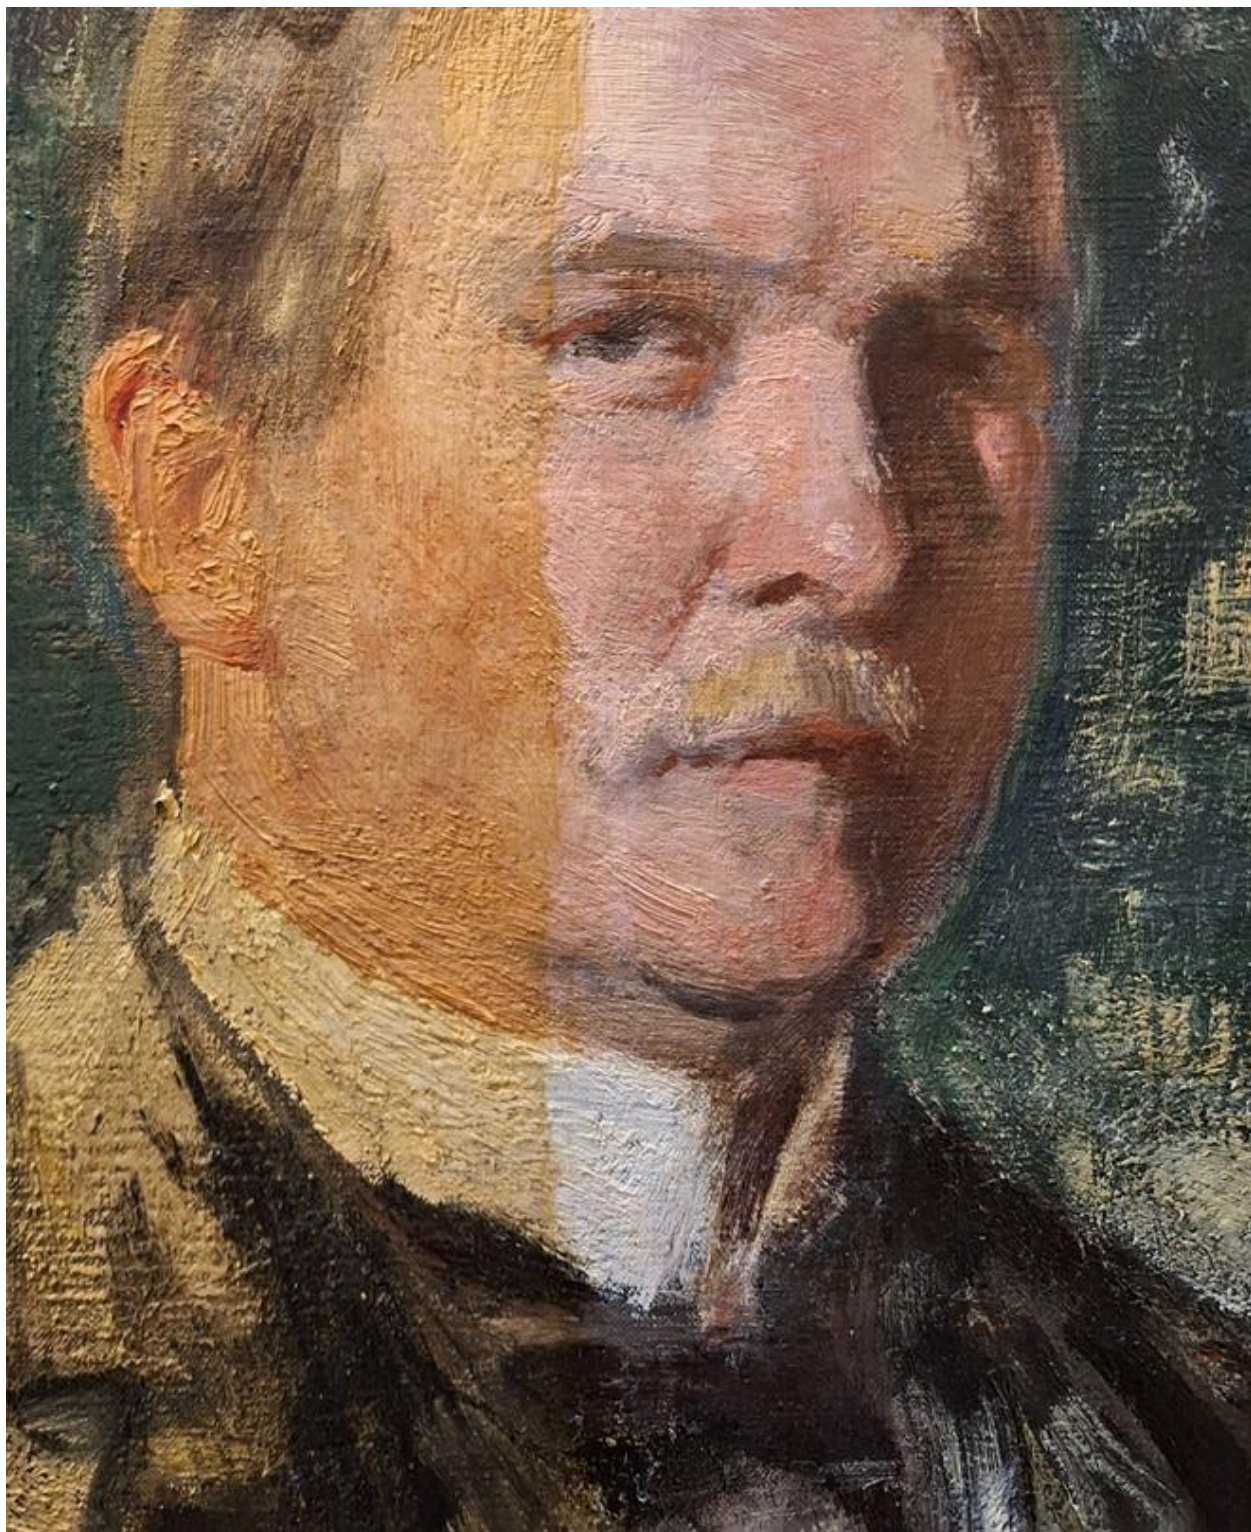
Detail of varnish removal from the face.
